Excellence in Facility Management

Five Federal Case Studies

The Facility Maintenance and Operations Committee (FMOC)

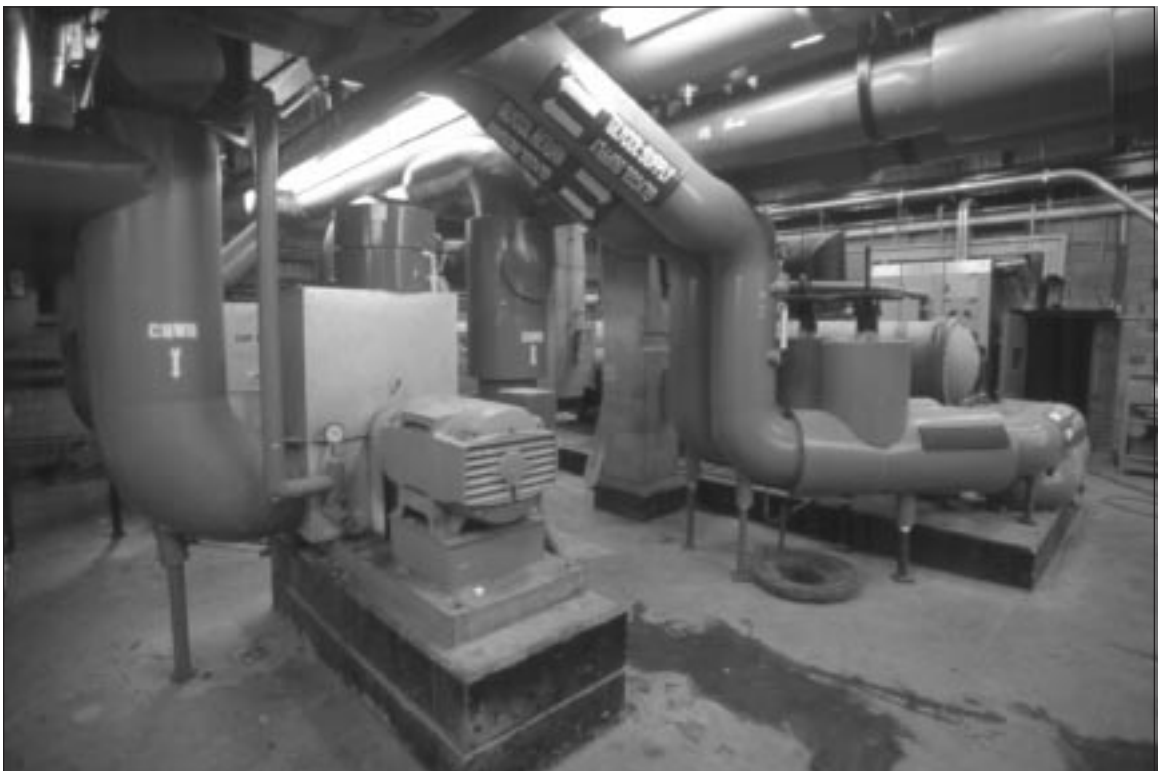
All USDA mechanical rooms were cleaned and polished as part of the maintenance upgrade. This spotless new chiller for the ice plant reflects the current conditions.

Another element in improving the overall HVAC system was to upgrade the mechanical rooms that house HVAC equipment. Over time, these spaces have been reconfigured to improve maintainability of the mechanical equipment, old decrepit lighting has been replaced, and the rooms have been cleaned up and painted. The improved work environment has resulted in increased pride in the critical building maintenance organization. Today lights in the utility rooms are turned off and there is much less trash littering the corners.

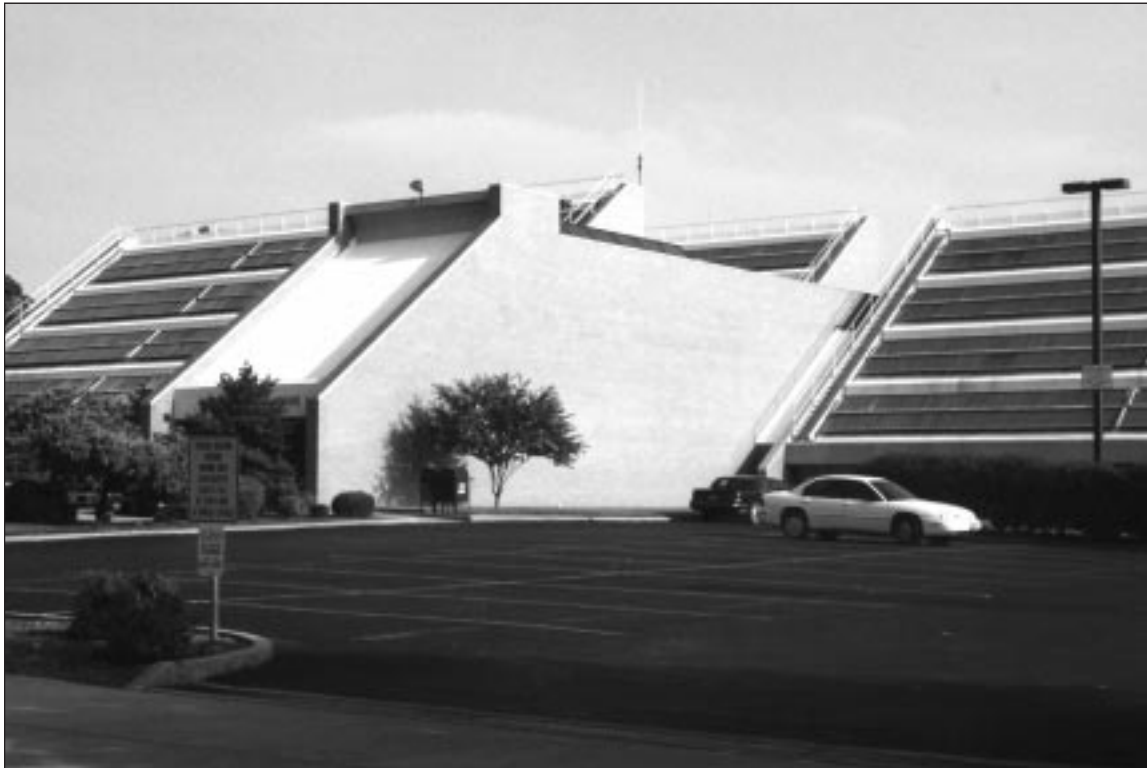
Solar arrays dictated the design of the south elevation of the Federal Office Building in Carbondale, Illinois

The fragile nature of the solar system left it quite vulnerable to recurrent damage inflicted by vandals. Vandalism normally occurred on weekends, when "partying" college students returned to their cars in the Carbondale building parking lot. The students found it amusing to throw empty beer bottles up at the exposed glass collector tubes. The unfortunate result was the loss of approximately 40,000 liters of water, as well as the chemicals

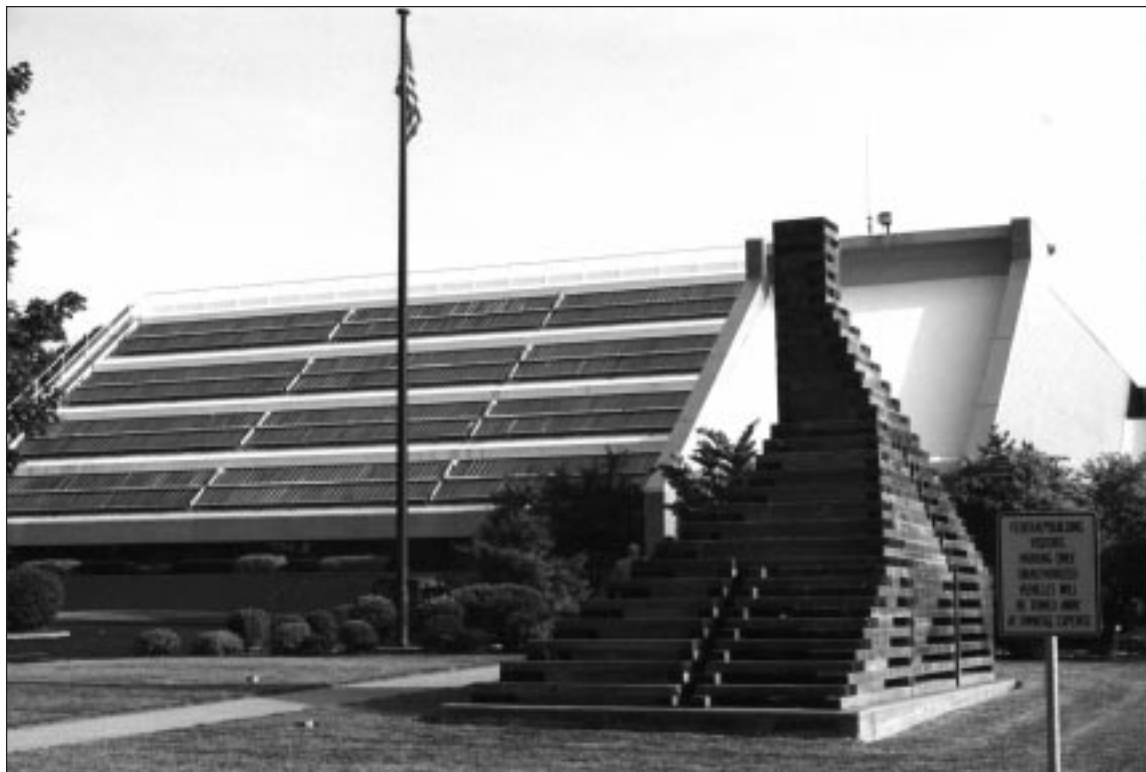
Wooden sculpture at entry was not sufficient to protect the vulnerable solar arrays.

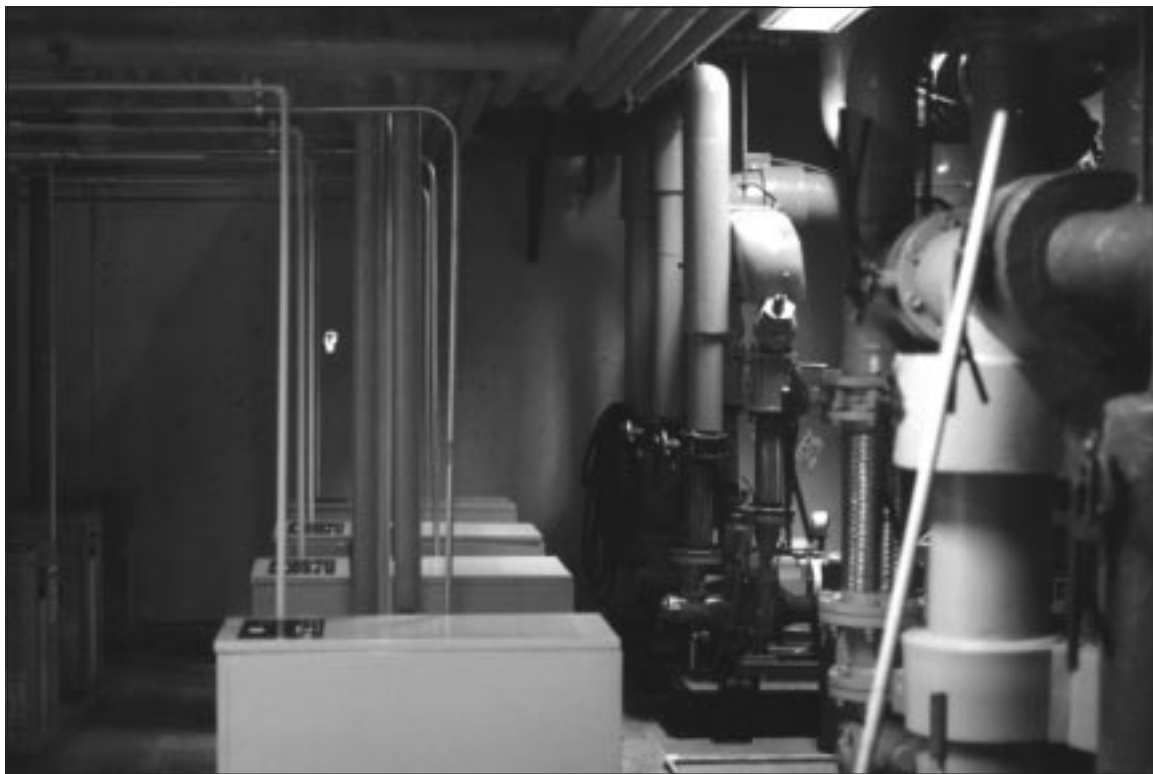
New packaged boilers are able to satisfy varying demand much more efficiently.

In 1986, the 360 KW electric boiler was replaced with a 1339 MBH gas fired boiler. In 1996, the single large gas boiler was subsequently replaced with ten smaller (175 MBH) more efficient gas fired packaged boilers. Now it is possible to stage the supply of hot water at a more efficient rate, with sufficient reserve. Another advantage is that boiler maintenance can be more easily scheduled and performed.

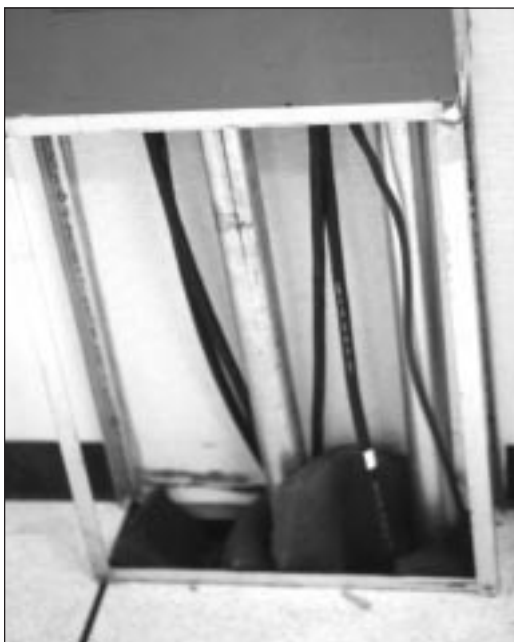
This simple method of insulating cabinets resulted in both cooling and heating savings.

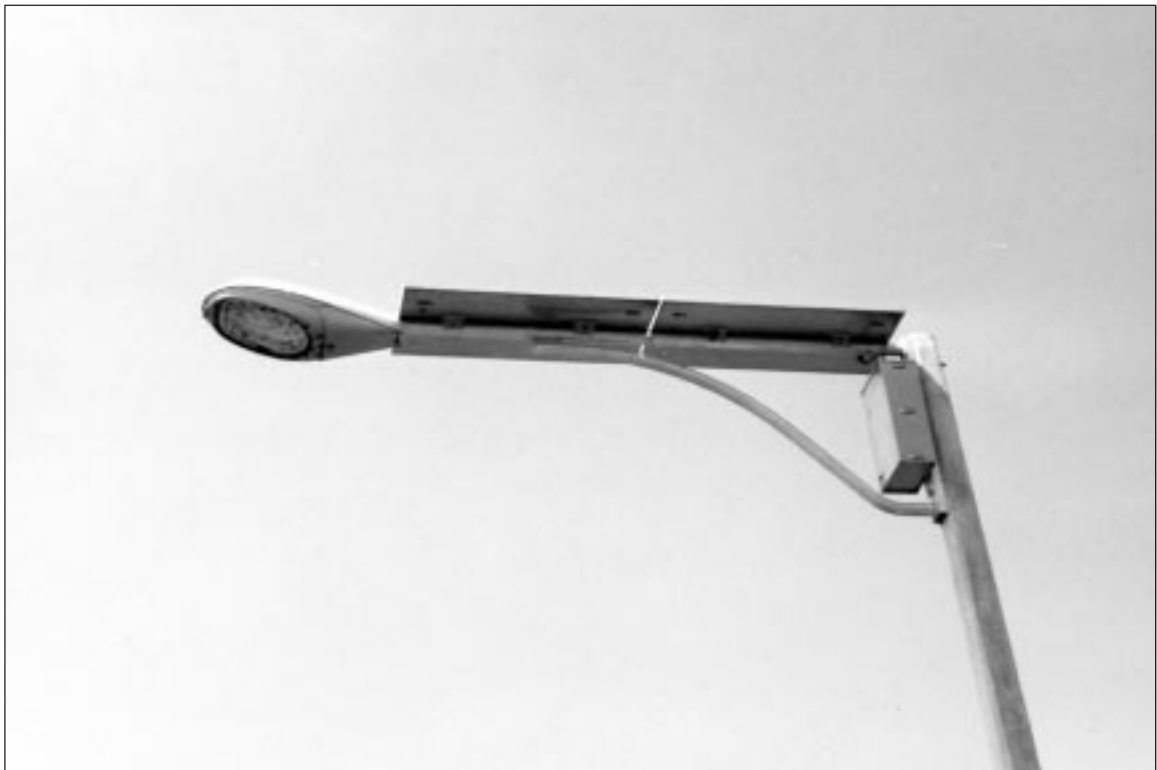
Photo-voltaic panels provide solar power for perimeter lights.

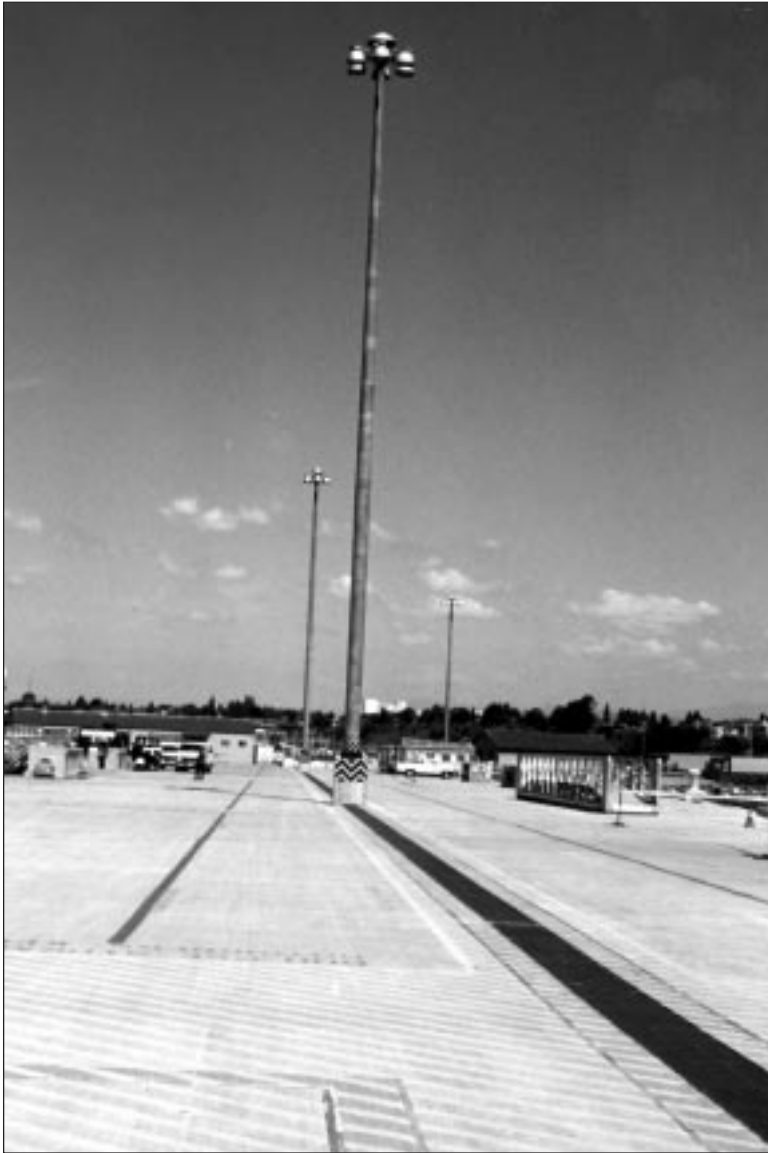
For ease of maintenance, these highly efficient lights can also be lowered to the ground.

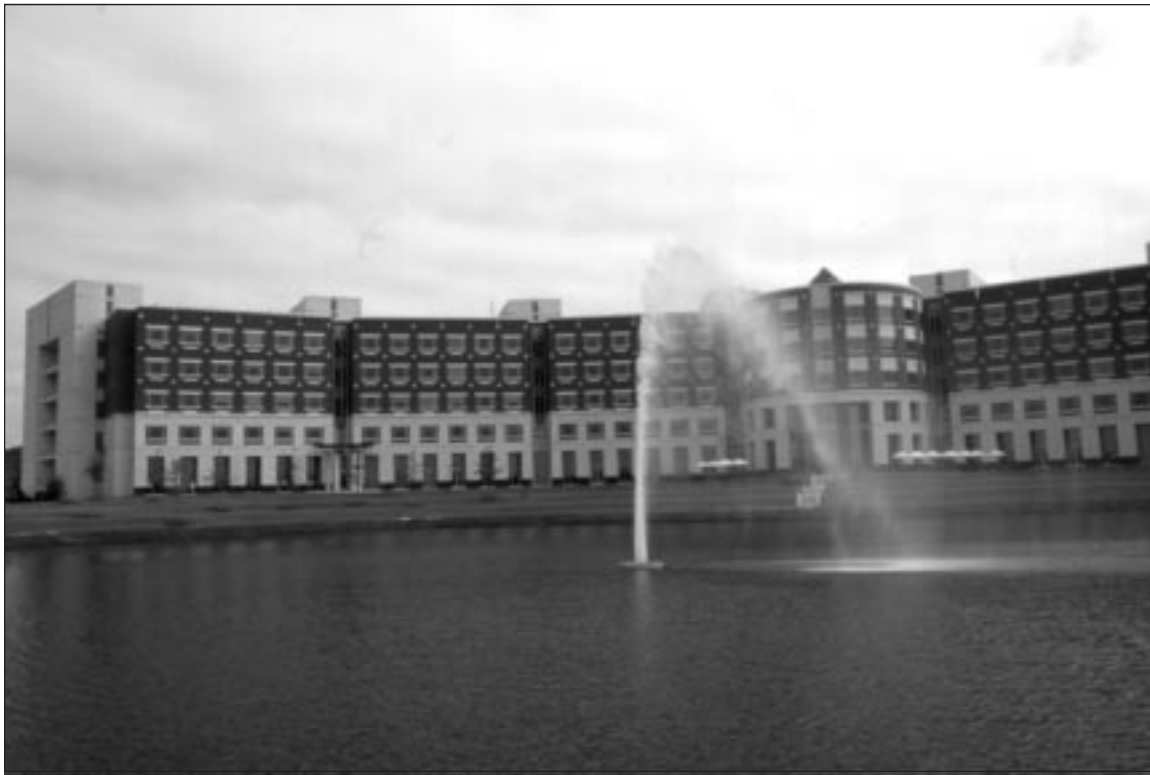
Aeration of the retention pond, which collects parking lot runoff, allows it to be used to water landscaping.

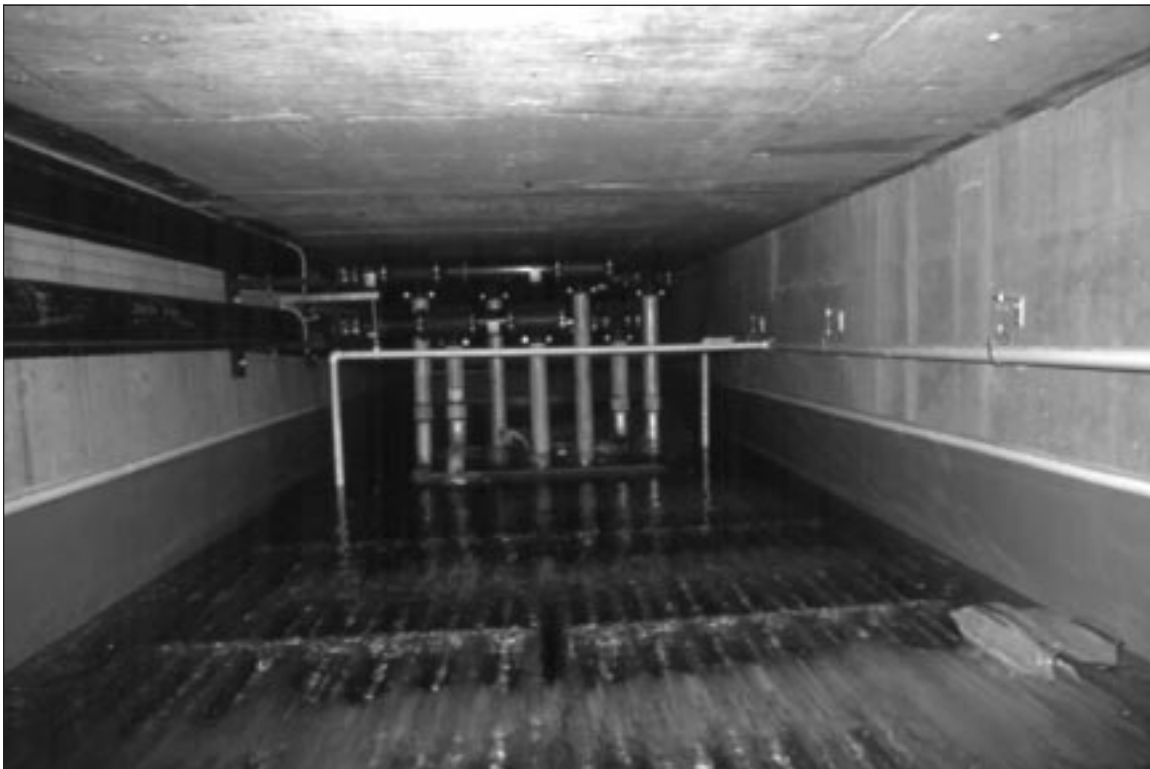
This “ice plant” is the heart of energy conservation for the DLA building. It has the capacity to provide “primary” cooling for substantial periods.

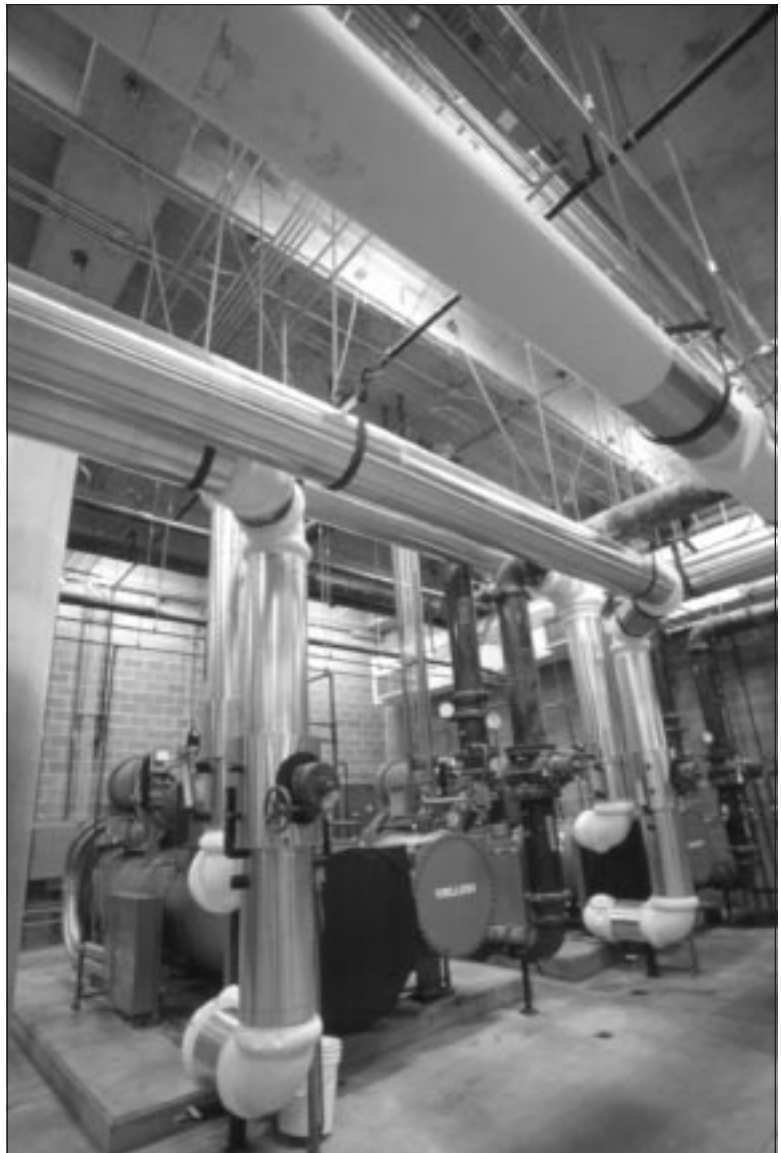
The immaculate chiller room at DLA is adjacent to the underground ice plant

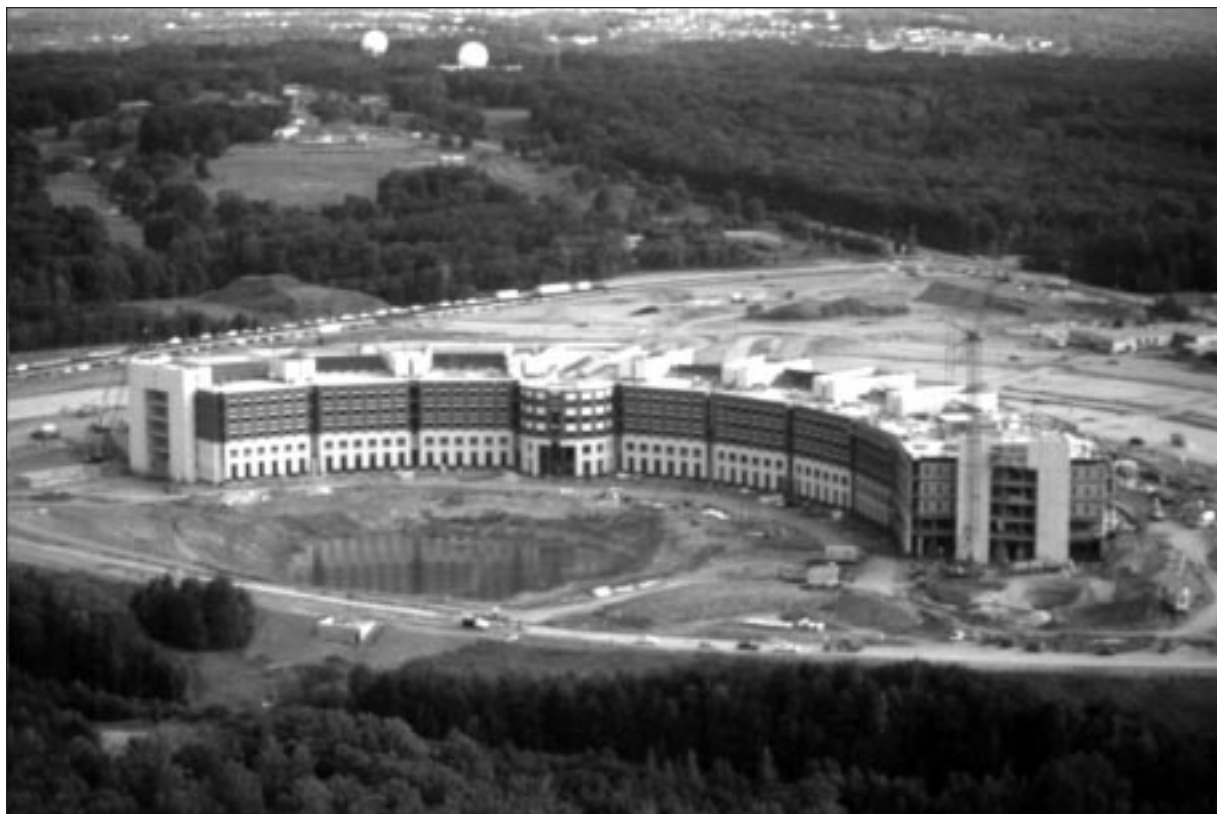
Early CAD layouts indicated that there was insufficient space in the original design. Two modules were added.
